Energy Audit – Malmesbury Town Hall

MALMESBURY
TOWN COUNCIL

Author	Reviewer	Date	Version
Nathan Tonkin	Adrian Newton	12/04/2022	1.0

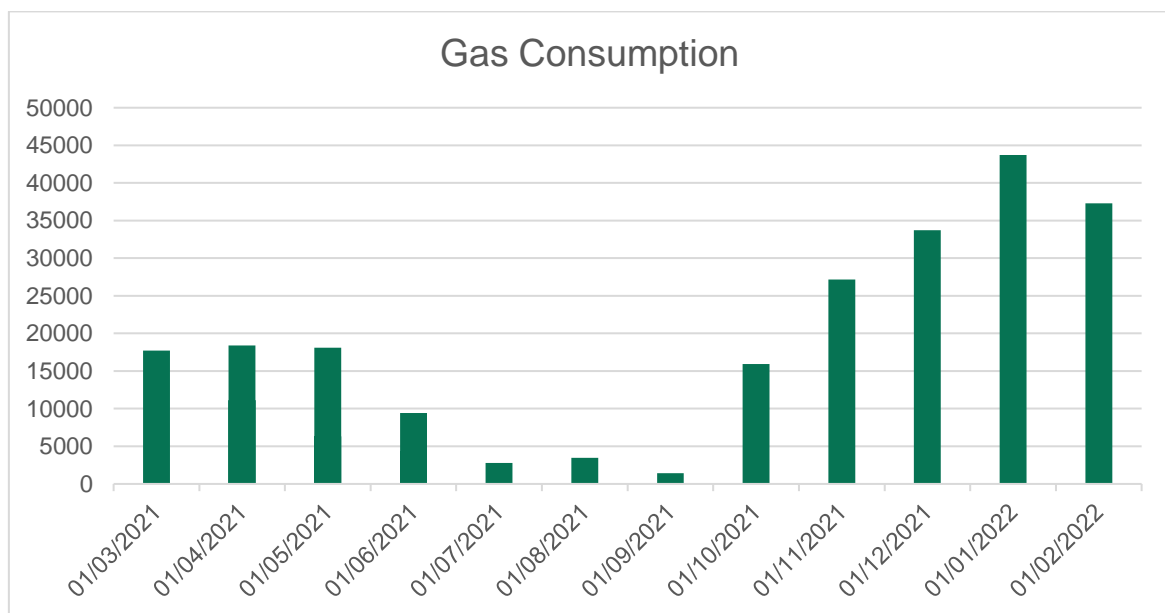
Figure 5: Gas Consumption/kWh, Mar 21 to Feb 22

Patterns of usage above show expected variation for a town hall:

- Peak gas needs November to April, when the heating system is on. Dips in heating needs in June/July/August (summer)
- Electricity profile shows a consistent demand with minor seasonal variation over winter months as lights are left on longer

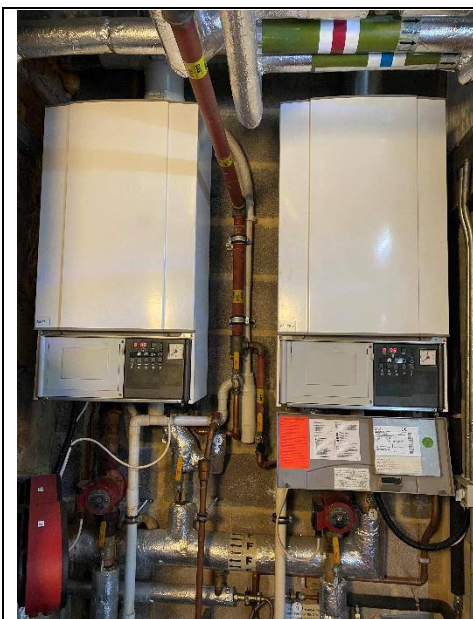
Generation: 2 x Rehema Quinta condensing gas boilers serve the building. They are approximately 14 years old, and are about 5-8 years away from their ‘end-of-life’ in terms of the need to replace them due to likelihood of failure and age.

Figure 8: 2x boilers serving the building

The existing boilers are expected to have another 5 years before the end of their serviceable life and it is therefore recommended that at that stage the replacement of the existing boilers for an air source heat pump is considered.

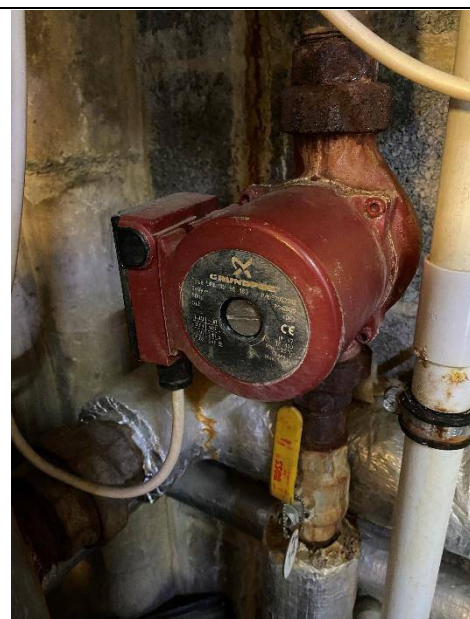
Figure 9: Unlagged Pumps

4x Grundfos pumps distribute heating through a LTHW system to the rest of the building. The pumps in the boiler room are unlagged and were recorded using a thermal gun at surface temperatures of ca. 68°C (see Figure 10). Other pipework was insulated but requires valve and flange jackets. There are separate distribution pipes and pumps for the two heating and hot water systems.

It is recommended that these areas of exposed pipework and fittings are insulated with bespoke flexible insulation jackets. These wrap around the various elements but can be removed and then replaced for any servicing activities.

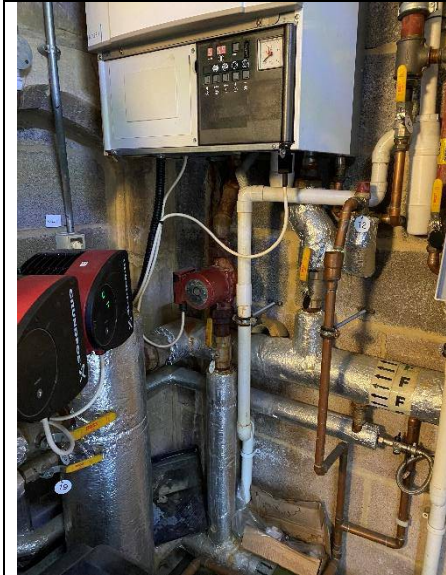
Figure 10: Unlagged pipework

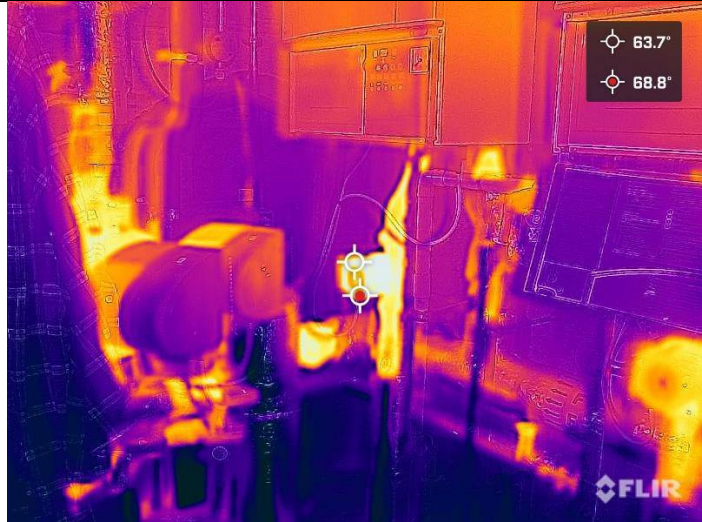
Figure 11: Thermal image of uninsulated pipework

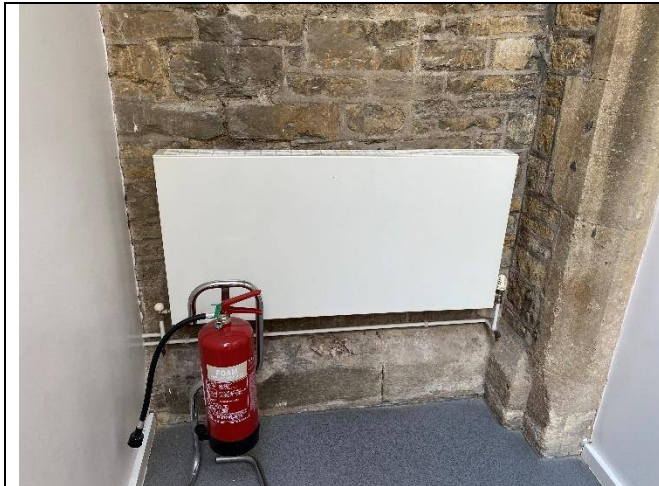
The building is served by wall mounted radiators. These have individual thermostatic valves which are monitored and switched off when not required.

Figure 12: Example of wall mounted hot water radiator

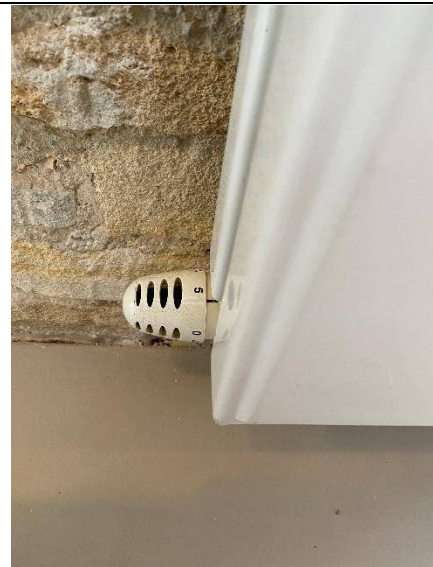
Figure 13: Thermostatic radiator valve

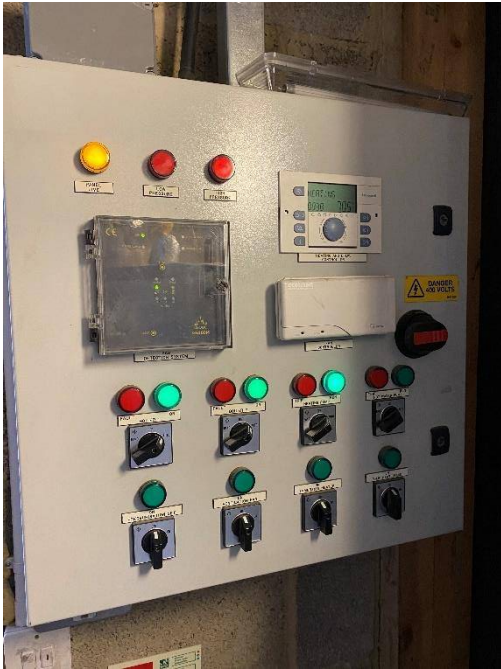
Heating delivery is controlled by a Honeywell controller in the plant room which is updated during general maintenance. These controls should be monitored by on site staff so occupancy can be matched with boiler output more accurately.

Figure 14: Honeywell heating controls

Currently the BMS system is only operated by an engineer who visits to perform routine maintenance on the boiler system. Giving control to the town hall would allow them to program the boiler to operate only when required. Currently the operating hours are unknown so the boilers could be firing when the town hall is unoccupied. Also, as the town hall opens during unusual and varied hours, allowing local control will allow the hall to only be heated when required. This change would reduce the operating hours of the boilers.

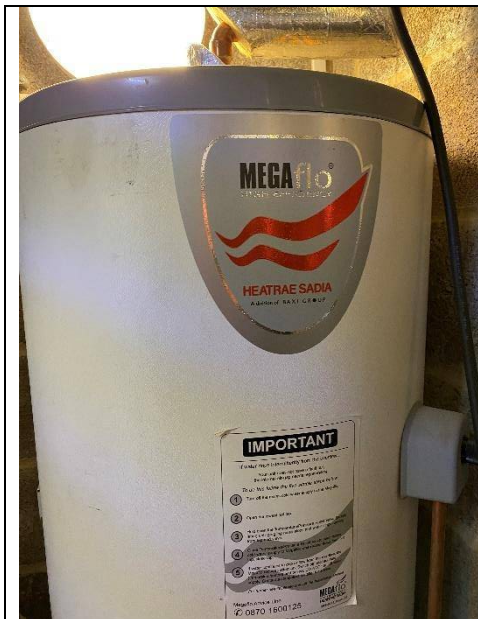
This is provided through taps across the building, across the multiple kitchens, toilets, and office sinks. It is heated through the main boilers and stored in an 250L MegaFlo CL250HE electric immersion heater with 200L Zilmet expansion tank.

Figure 15: MegaFlo CL250HE electric immersion heater

Along with the heating system, the hot water system should be considered for an upgrade to an ASHP. The current system still uses a gas fired boiler to heat the water before moving onto efficient electrical heating. To become fully carbon neutral the town hall should move away from all gas consumption.

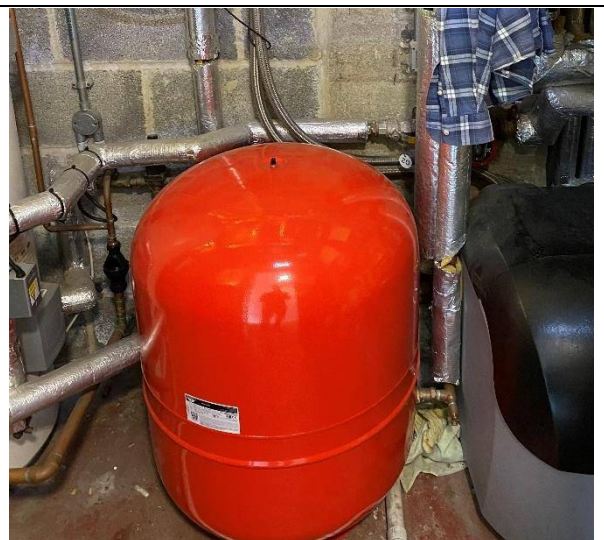
Figure 16: Zilmet expansion tank

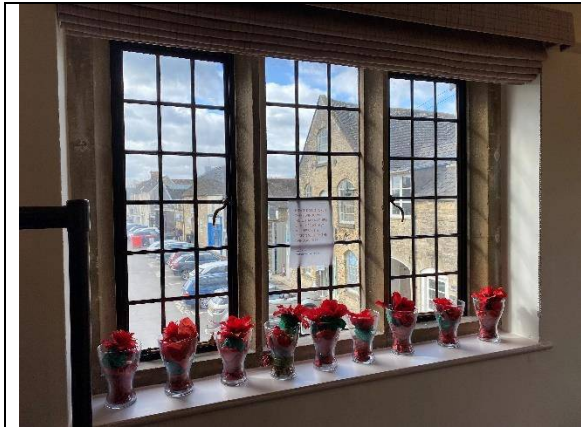
Most external windows are single glazed, metal frame in areas of original construction. A handful have had additional double-glazed frames built on the interior to reduce heat loss, without affecting the exterior appearance. Others, such as seen at the entrance to the building have been upgraded to double glazing. All windows and doors in the modern 2006 extension are double glazed as per the building regulations of the time.

Figure 19: Typical glazing across building

The introduction of secondary glazing would considerably reduce the heat loss through the existing windows and improve both thermal comfort and noise levels as well as providing added security.

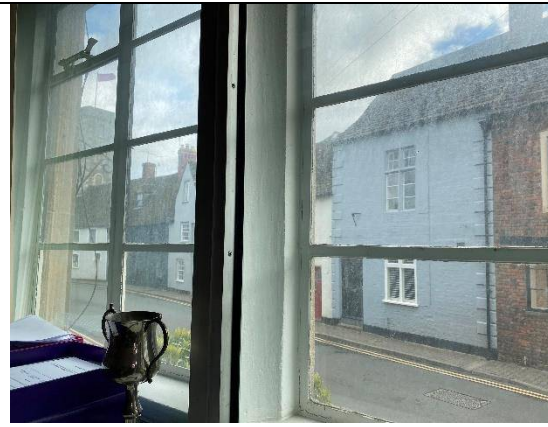
Figure 20: Example of retrofit double-glazed interior windows to reduce heat loss

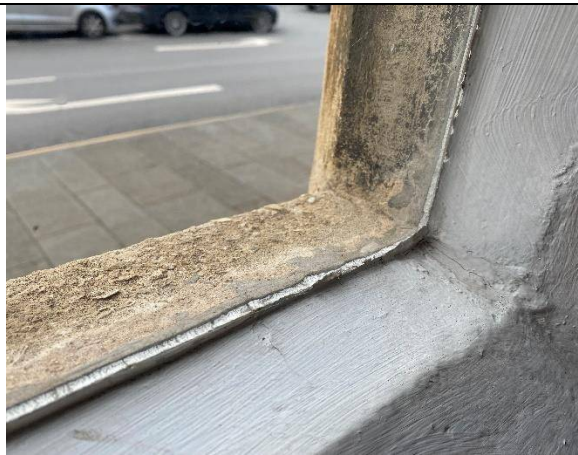
Figure 21: Close-up showing single glazed pane

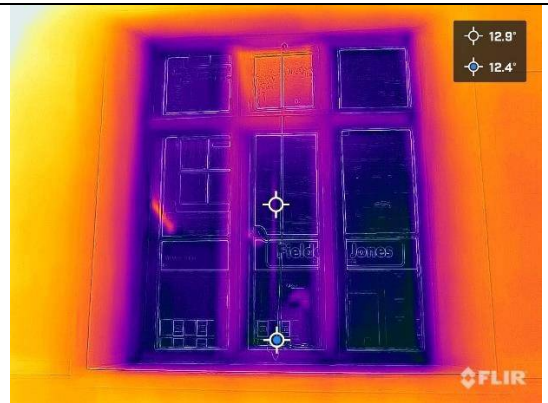
Figure 22: IR photo showing heat loss through a single glazed window in The Old School Room

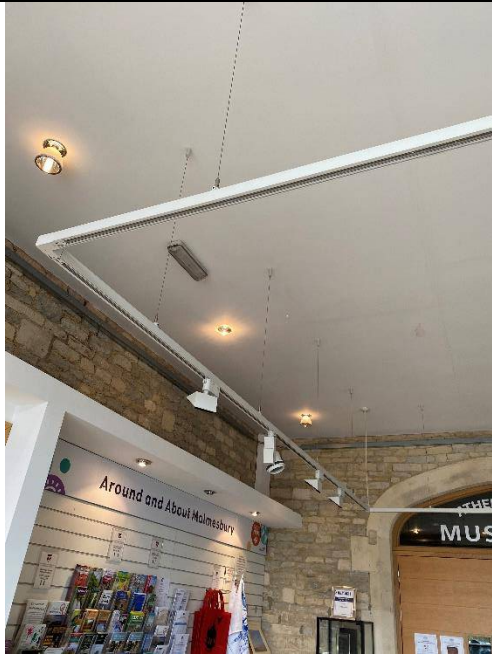
There are still some significant areas still covered by halogen or tungsten filament bulbs which should be looked at to replace.

Figure 23: Typical lighting in main areas

The lighting around the building is being slowly upgraded to LED lighting. However, there are many fixtures and fittings around the building which have yet to be changed. It is recommended that the fittings are all changed for LED. There are a vast number of specifications of LED lights on the market, but it is recommended that any LED light should come with branded chips and drivers and offer a 5-year warranty. Besides the energy saving, moving to LED lighting will provide a high quality of light output into the space and will reduce maintenance costs as there will be no lamps/light bulbs that need to be changed within these units.

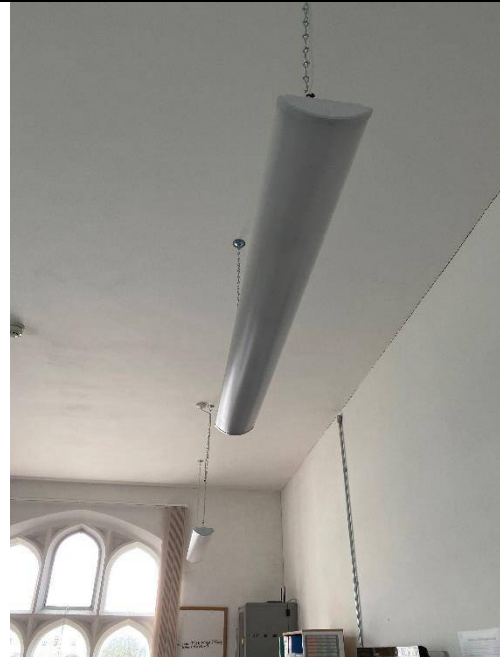
Figure 24: LED lighting in main office

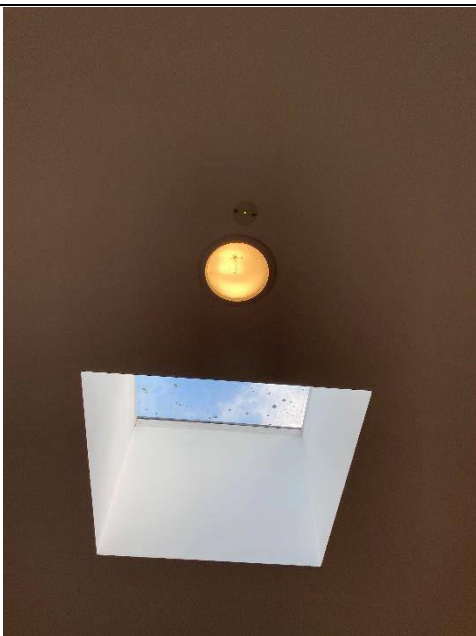
Figure 25: Skylights providing passive lighting in corridors along with a halogen light fitting

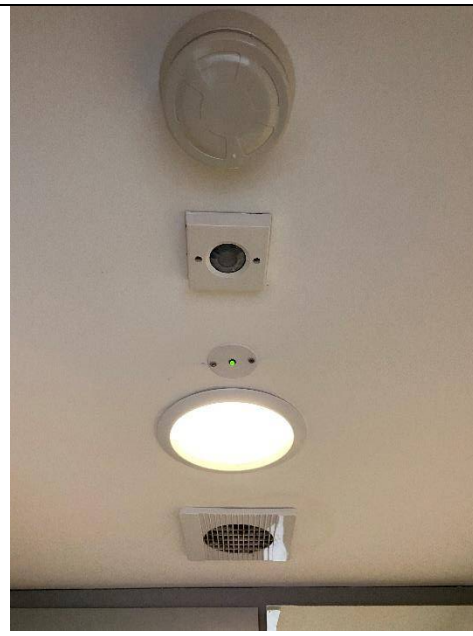
Figure 26: PIR movement controls in toilets

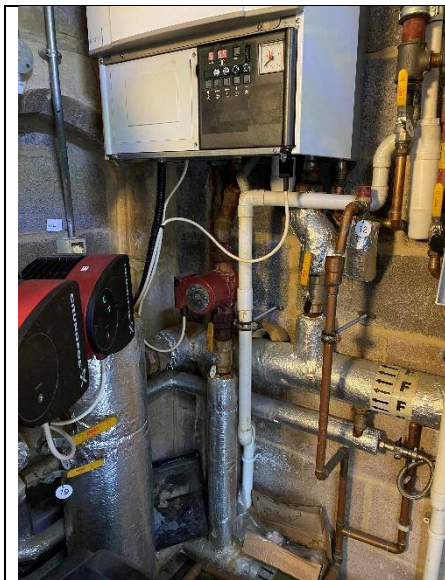
The pipework within the plant room has the majority of its straight lengths insulated but the more complex shaped pipework fittings, such as flanges and valves, have been left uninsulated. These exposed areas of pipework contribute significantly to heat loss from the system and make the plant room unnecessarily warm. The exposed hot surfaces also represent a health and safety risk of burns for those working in the area.

Figure 27: Unlagged pipework

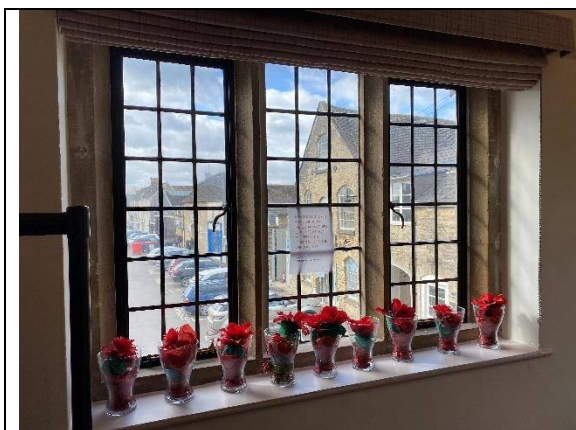
Figure 31: Typical glazing across building

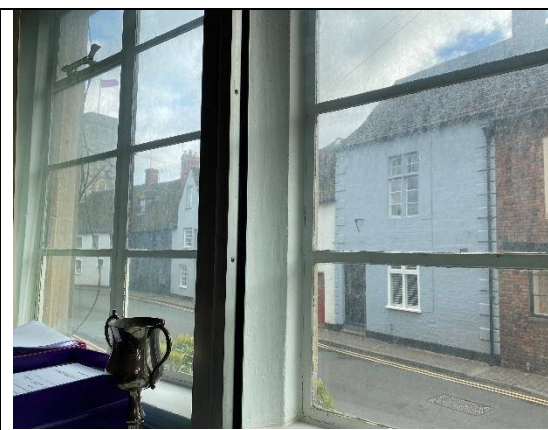
Figure 32: Example of retrofit double-glazed interior windows to reduce heat loss

Any possible installation would need to be carefully specified, such as the work that has been already carried out in the office downstairs. This will incur some additional cost. Achieving a well-insulated building will facilitate reduction of heating costs and is recommended before installing a heat pump.

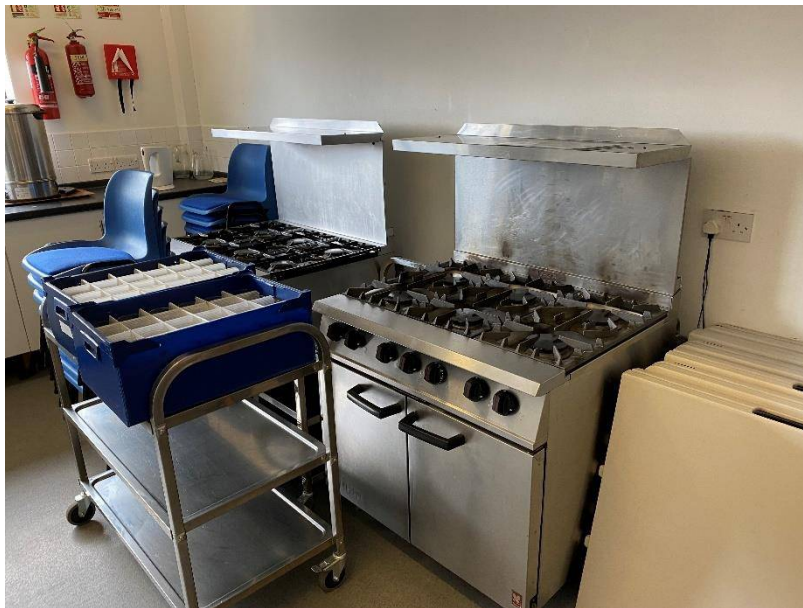
Currently the majority of the cooking taking place in the main catering kitchen is undertaken with gas-fired appliances (two, 6-burner ranges, one double oven). The small kitchen on the ground floor already uses electric appliances, but these are outdated and should be considered for replacement along with the main kitchen.

Figure 40: Existing gas fired appliances considered for replacement

It is recommended that these units are replaced with electrically powered units when they reach the end of their life in approximately 10 years. It is estimated that the total cost of replacing these units is £10,000. With the current cost of gas and electricity it does not provide an attractive payback, but with the ever-changing market this could improve as the cost of gas increases.
