Abbey Steps and Bridge

Malmesbury & District Conservation Group
January 2018

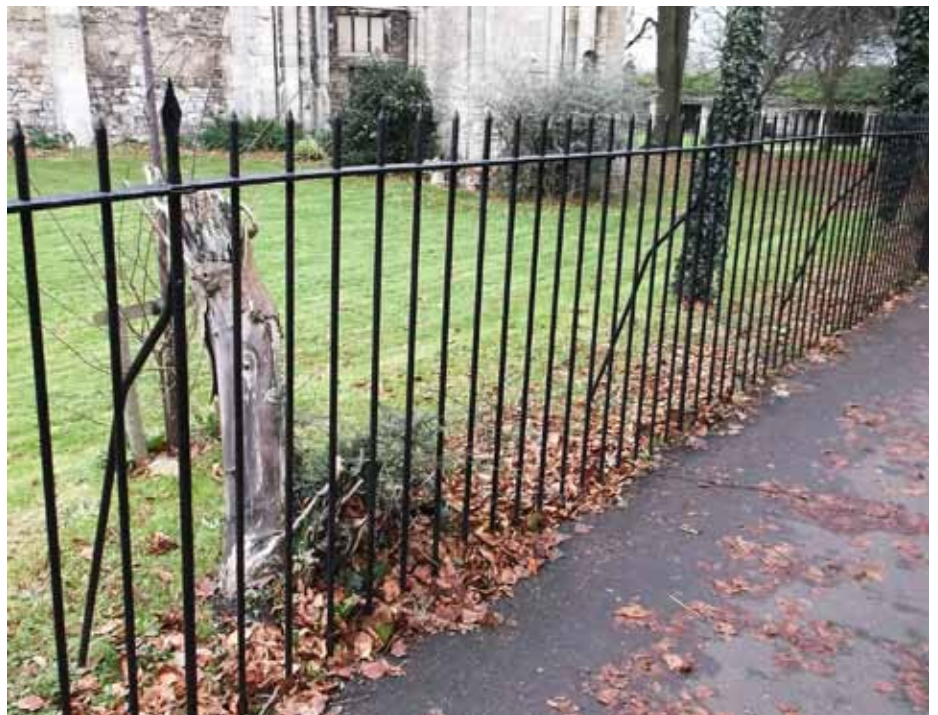
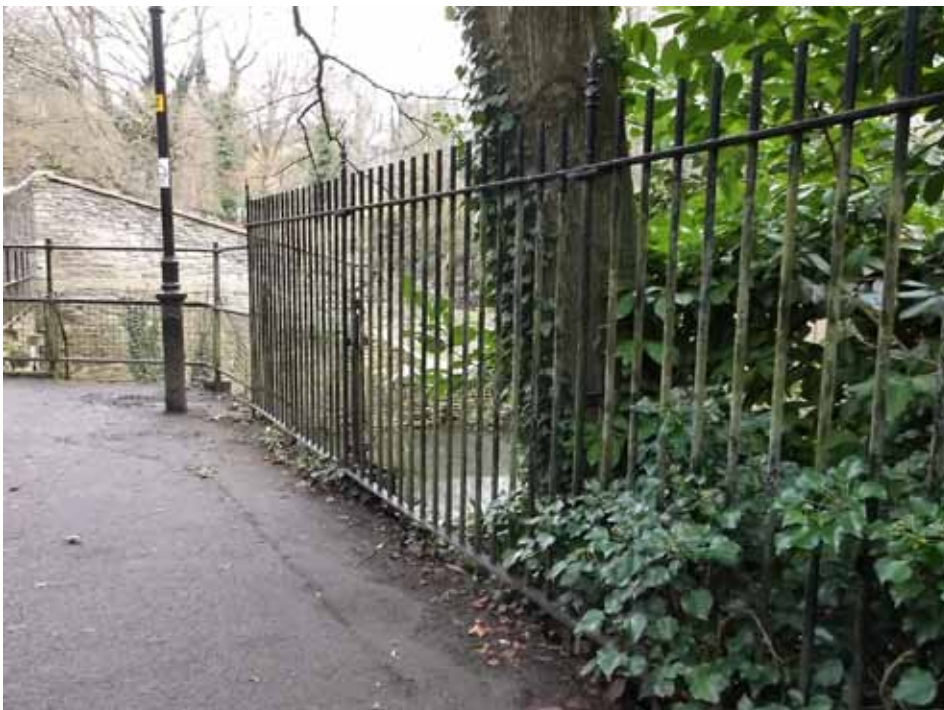
The railings by the east end of the Abbey and those enclosing Abbey House garden are generally in good condition.

1. The Abbey railings

- b. The installation of metal railings (of the same pattern as shown in photographs 1 and 2) on the north side of the bridge to the bank behind the signboards. This would deliver an enhancement set out in the Malmesbury Conservation Area Management Plan (page 27) and Neighbourhood Plan.

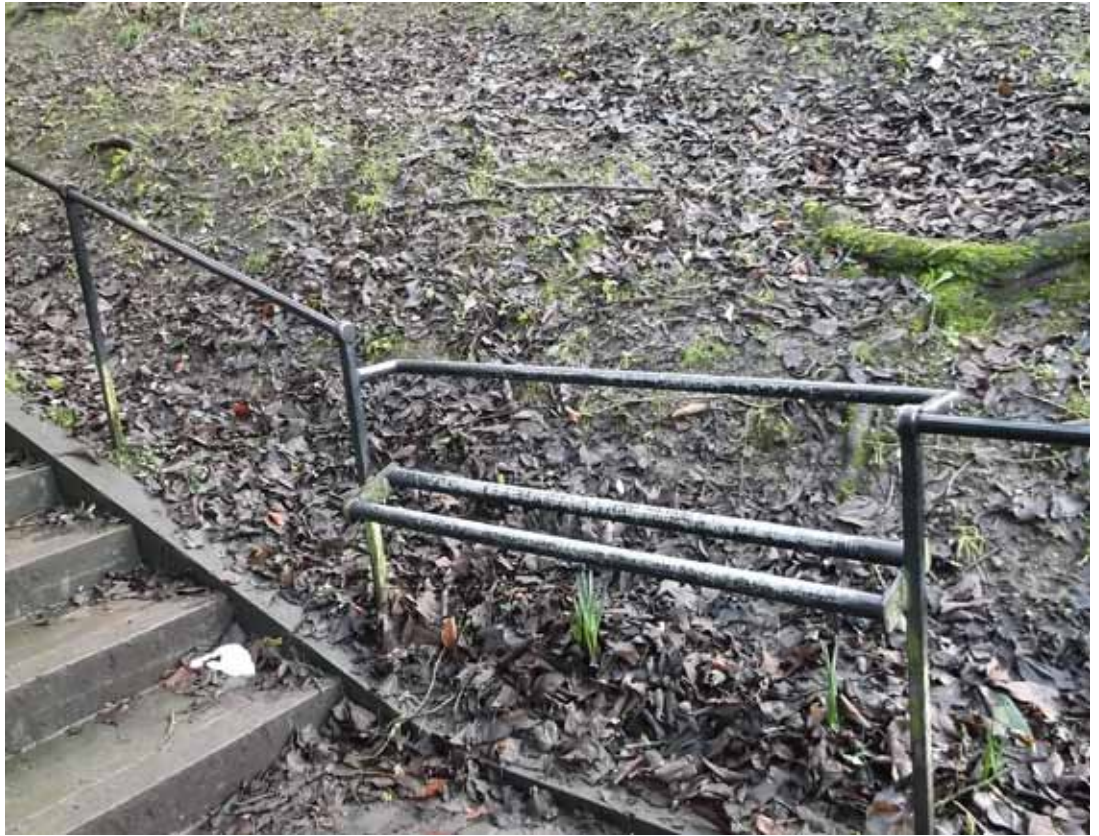
2. The Abbey House garden railings extend from the top of the steps to the bridge. The appearance would be improved by the removal of green algae.

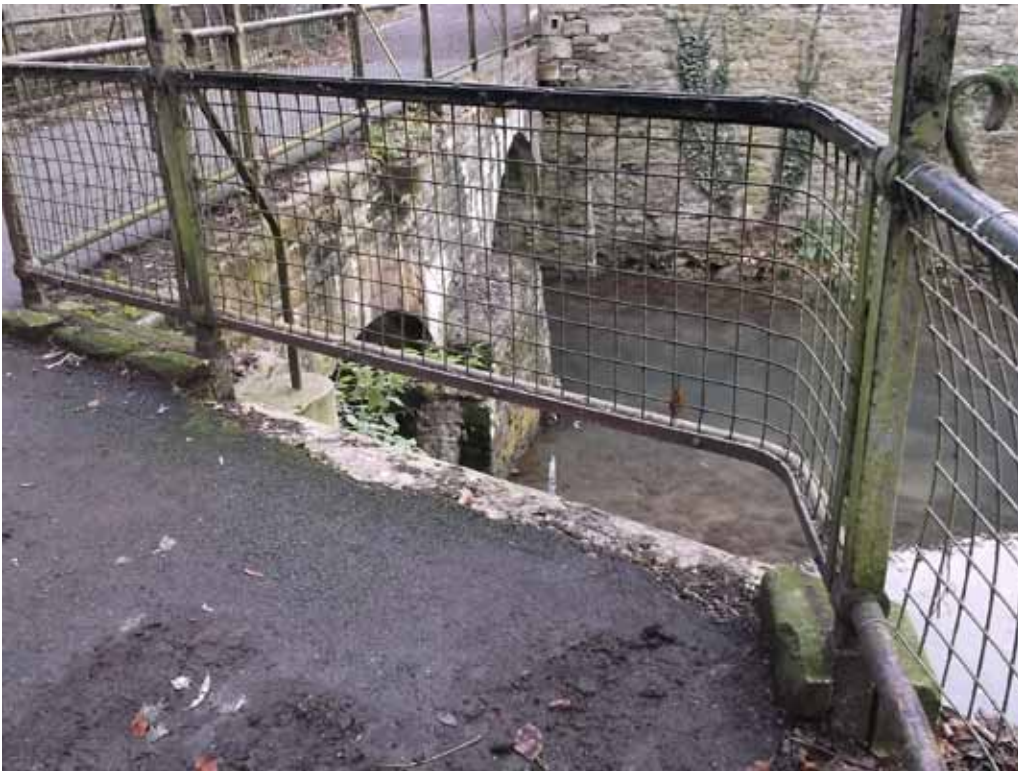
3. The handrails for the steps are generally in good condition with the exception of the half-way resting place (put in by Malmesbury Town Council) which needs re-painting.

4. Malmesbury Town Council is requested to urgently raise this matter with Wiltshire Council and also offer funding for it. The Town Council should also arrange to repaint the resting place (photograph 3).

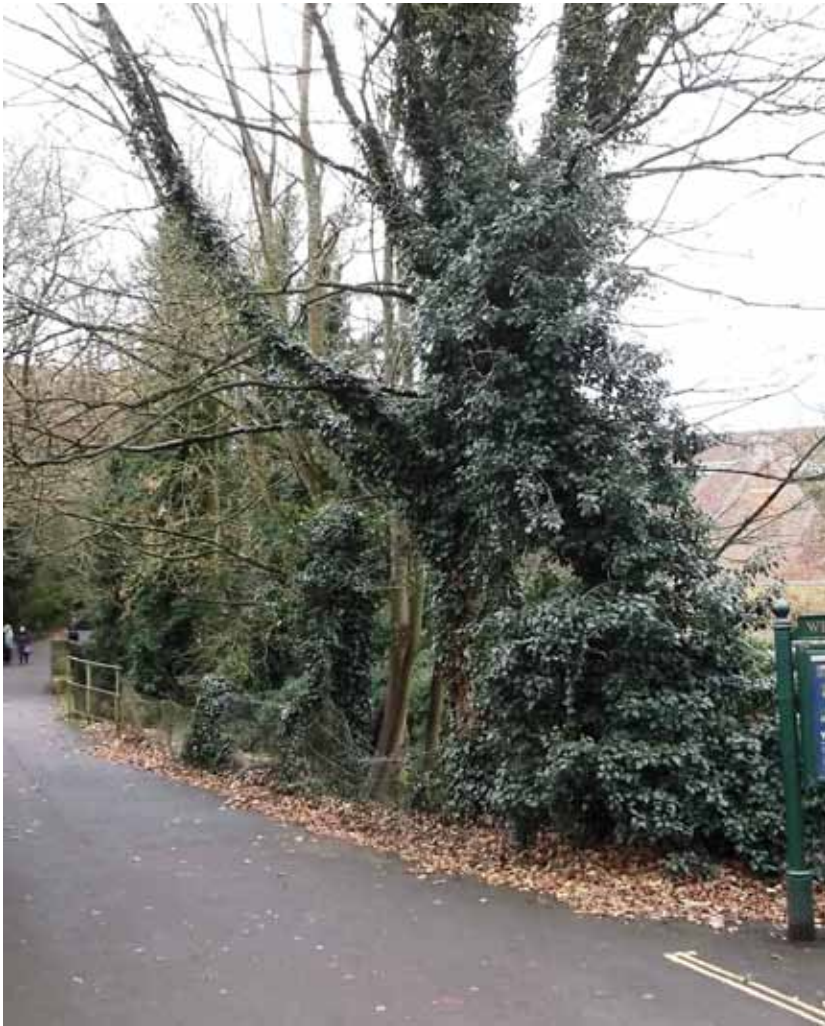
4. Some of the coping stones on the downstream side of the bridge are missing. Wiltshire Council placed temporary guarding here for some time as it is regarded as a safety hazard. The mesh ought to be straightened and the railings painted.

- c. Replacement of the missing coping stones on the bridge with repainting of the metalwork.
3. Malmesbury Civic Trust would be prepared to part fund this project.

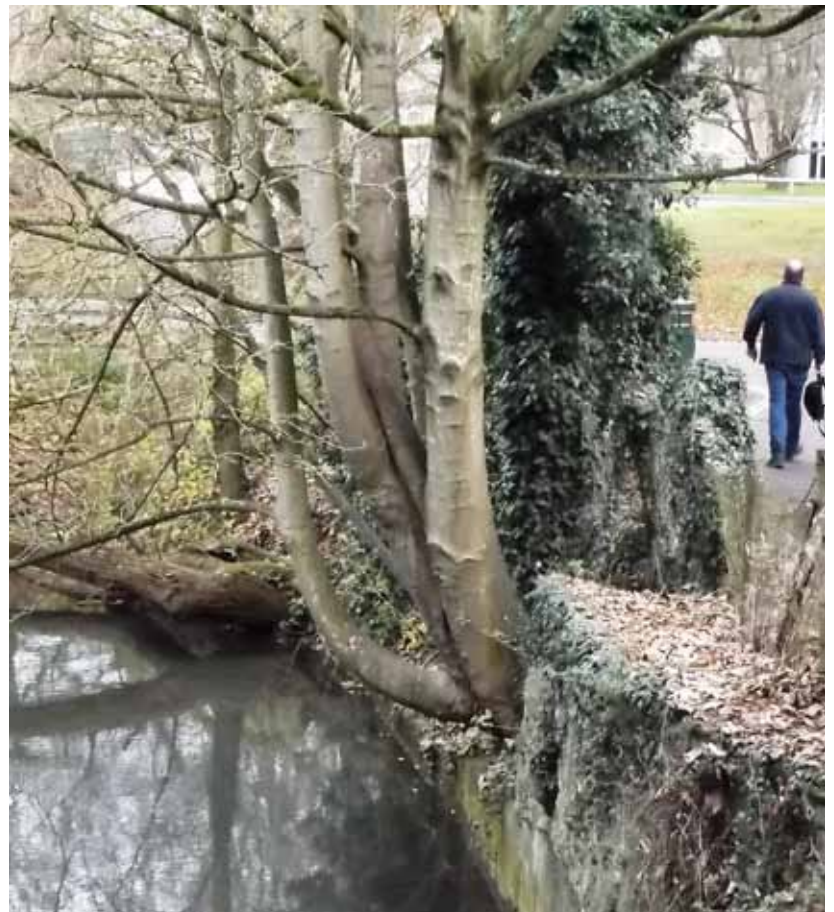
5. To the north side of the bridge there is an insecure chainlink fence which has been beaten down, allowing easier access to the river. This safety issue should be dealt with. There are a number of untidy trees along the river bank. Some of the trees have had their tops removed but are now covered with ivy.

6. There are several large tree trunks growing out of the river bank one of which has fallen. Should these others fall it is likely the leverage arising from their weight would cause considerable damage to the roadway.

2. This project should contain the following elements:
 - a. The felling of the two trees growing out of the riverbank shown in photograph 6 together with the removal of the fallen tree and work to reduce the other trees as recommended by a tree surgeon.
